ICSO 2016

Caveats and pitfalls of high energy UV laser operation on ground

L. Mondin¹, D. Wernham¹, F.F. Era³, H. Kheyrandish⁵, A. Bolkhovitinov¹, A. Baselga Mateo¹, A. Ciapponi¹, C. Heese¹, T. Ivanov¹, M. Hippler², D. Thibault⁴, G. Van Papendrecht¹, W. Riede², Y. Butenko¹, H. Schroeder²

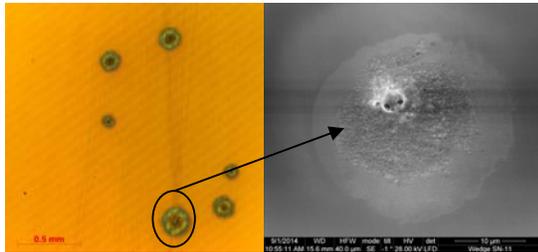
LIC is not, however, an effect purely limited to hard vacuum conditions. LIC deposits can and will form at ambient pressure. The presence of O₂ is a deterrent to the LIC formation in these conditions too. As such operation with normal dry air is to be preferred to operation in nitrogen (or any other mixture not containing reactive oxidants), as evidenced in *Figure II-1*.

Figure II-1 LIC induced damage event after irradiation in N₂ ambient (microscope image (left) and detail with Atomic Force Microscope (right))

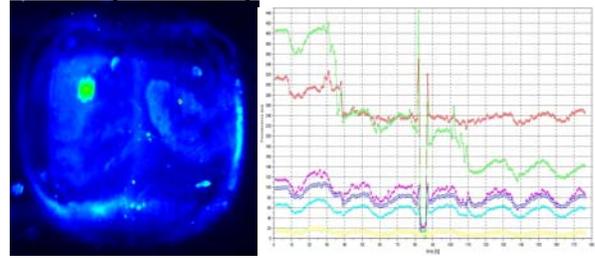
Figure III-1 Fluorescence image FM-A TV test campaign and different areas of interest evolution over test campaign.

On the other hand, as shown in *Figure III-1*, fluorescence based setup can be used as a good indicator of the air quality and alerts raised as needed. Fluorescence verification remains an efficient check during testing but cannot be used to demarcate the usable gas supplies a priori.

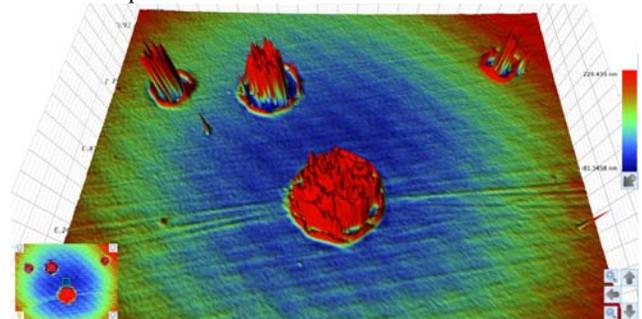
Figure III-2 white light interferometry measurement for LIC induced event presented in *Figure II-1*.

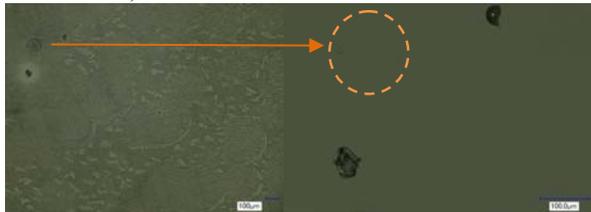
Figure III-3 Beam footprint visualized using huffing (left). Visible droplets on surface in beam footprint after huffing (right). Successful test no WLIM detectable growth.

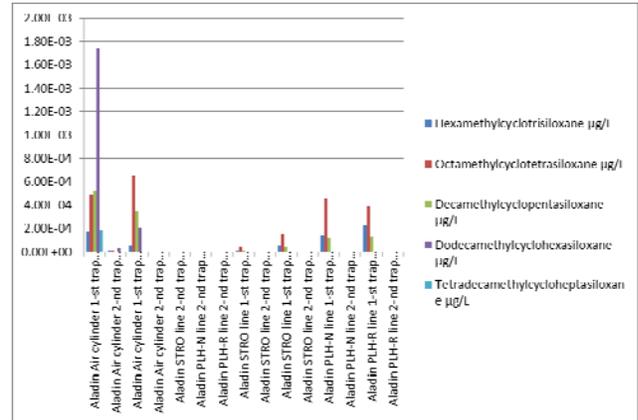
In series usage of two such traps allows to reach much lower silicones concentration than those seen on the given purge line as can be shown in Figure III-4.

Figure III-4 Reduced concentration [µg/L] of silicone contaminants after two in series traps.

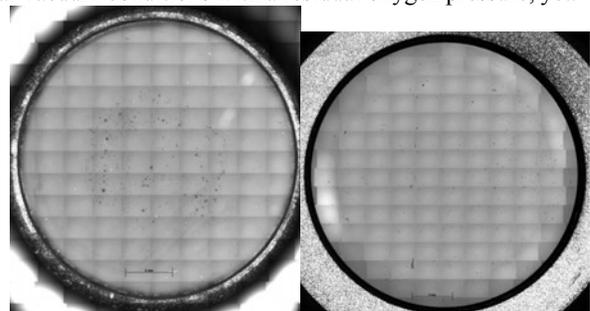
Figure IV-1 Left: input side of laser window, Right: output side. Same environment on both sides.

Analogously features are more abundant on the laser input surface of a transmissive optic. This is well evidenced by the instrument input window sample in *Figure IV-1*. The left-hand (laser input side) shows a high concentration of features in the beam foot-print, the concentration is random and not fluence dependent. The output surface shows dust and a few isolated absorbing features in the central laser irradiated area.

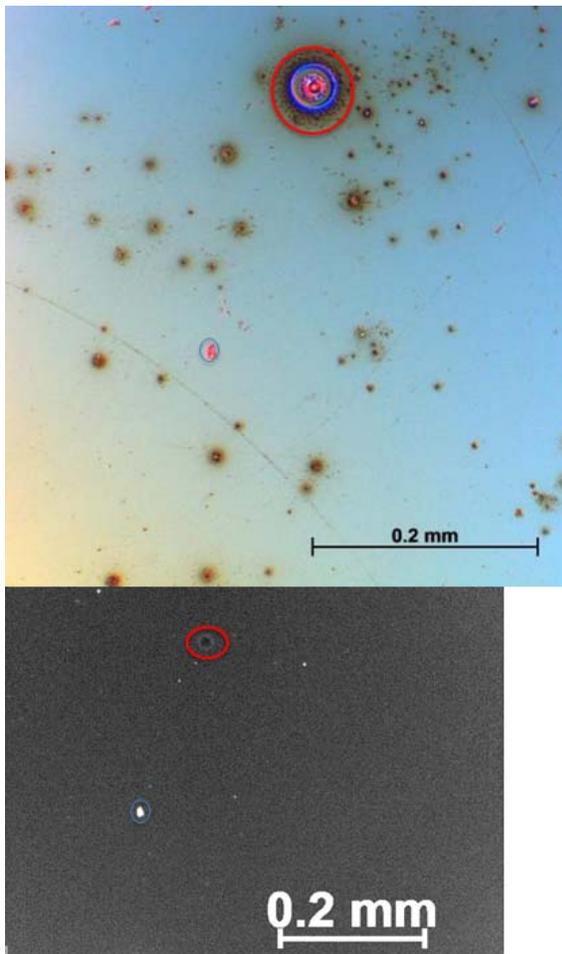
On the laser input side, at higher magnification, the features have a dot-like appearance, and are commingled with rare, small compared to beam size ($\approx 100\mu\text{m}$ vs. $5\times 6\text{mm}$) laser damages, *Figure IV-2*. Same morphology is evidenced in *Figure IV-4* for output surface.

Figure IV-2 Input surface: absorbing features, organic particle and small damage. Bright field, fluorescence.

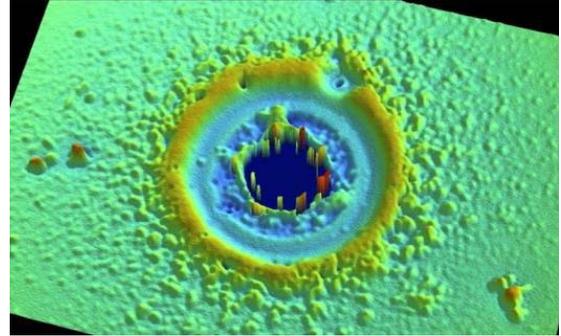
Figure IV-3 WRLM of damage area presenting a few of the absorbing features.

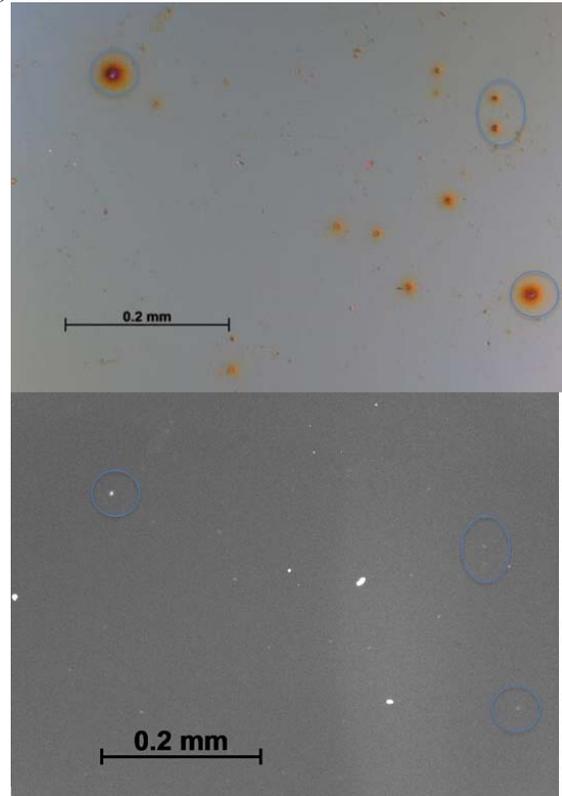
The absorbing features are very faintly emissive at best as it pertains to fluorescence. Not fluorescing, but for the annulus of the damage area as can be seen on the input surface, *Figure IV-2* or only faintly fluorescing, as can be seen on the output side, *Figure IV-4*.

Figure IV-4 Output surface detail bright field and fluorescence.

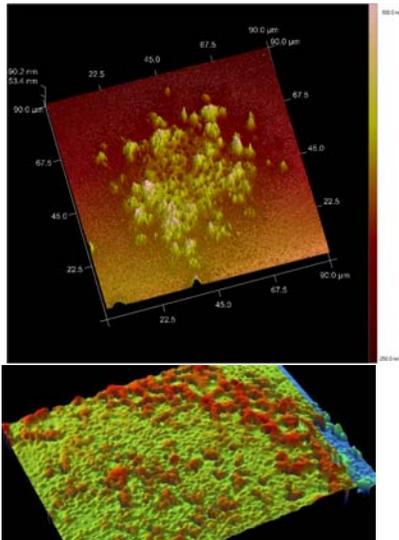
The features are located on the surface of the optic; the damage structure position with respect to the same is less easily monitored, due to lack of reflectivity in the central area (*Figure IV-3*). Atomic Force Microscopy confirms the position of the absorbing features (*Figure IV-5*).

Figure IV-5 AFM (top) and WLIM (bottom) micrographs of instrument output window.

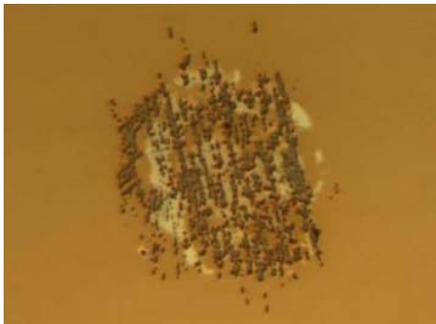
Figure IV-6 Power Laser Head samples 01 from DLR showing silicone based contamination covering whole beam area.

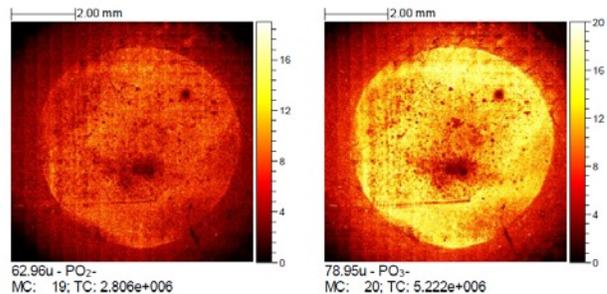
Consistently the presence of Phosphates (PO_2^- and PO_3^-) on the optical surface in conjunction with the laser foot-print is evidenced, *Figure IV-7*.

Figure IV-7 Aladin Laser FM-A output window: SIMS map for negative phosphate ions. Beam footprint evident, depletion co-located with damage structures.

PDMS, Cl and F are also present in control areas outside the beam, so are the phosphates but, as evidenced in *Figure IV-7*, with lower levels.

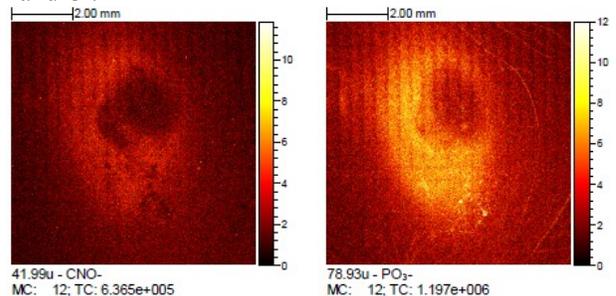
Figure IV-8 Long Term Sample A, halo at extrema of beam.

The phosphate/ amine deposit is not always covering the whole beam footprint as seen in *Figure IV-8*, but is occasionally present as a halo surrounding the beam.

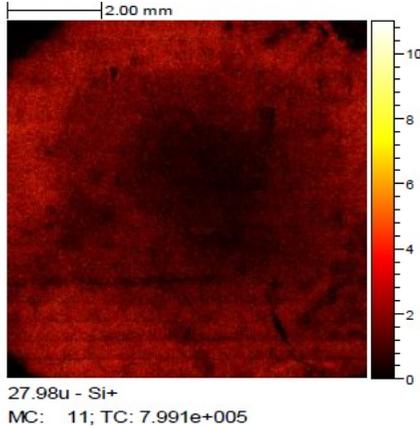
The corresponding depletion of Si in the SIMS map of the positive ions corresponding to the laser footprint shows that a deposit is covering the optical surface (*Figure IV-9*). This is also a generic observation which holds for all samples investigated so far.

Figure IV-9 Aladin Laser FM-A output window SIMS map of positive ions. Si depletion is evident in the beam footprint.

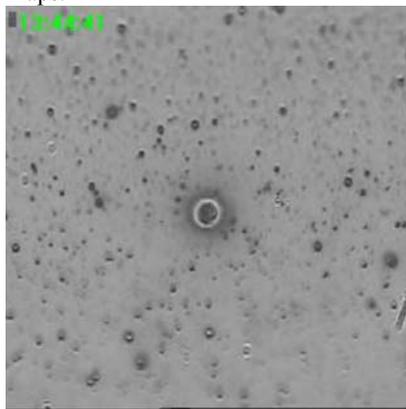
If we now concentrate on an area around a damage feature such as the one observed on the Aladin FM-A output window the optical image (*Figure IV-10*) shows a clear correlation with the chemical maps.

Figure IV-10 Aladin Laser FM-A output window: optical microscope image of detailed area of analysis taken from ToF-SIMS set-up.

Correlation is obvious with the phosphates which show a significant depletion in the center of the damage structure, a bright ring and a second darker annulus.

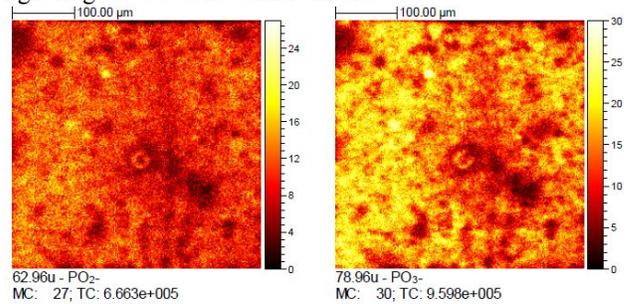
Figure IV-11 Aladin Laser FM-A output window: SIMS map of negative ions before Ar sputter cleaning.

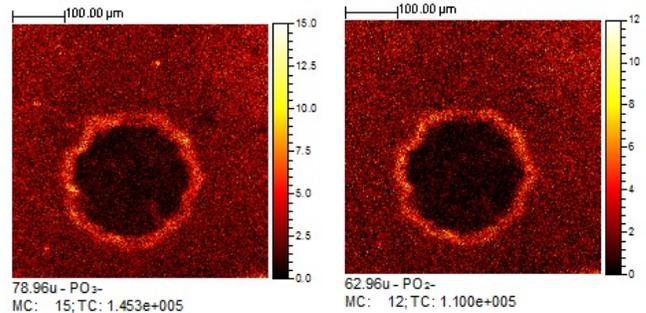
Figure IV-12 LIC induced damage after laser irradiation in N₂ ambient ToF-SIMS detail of circled area.

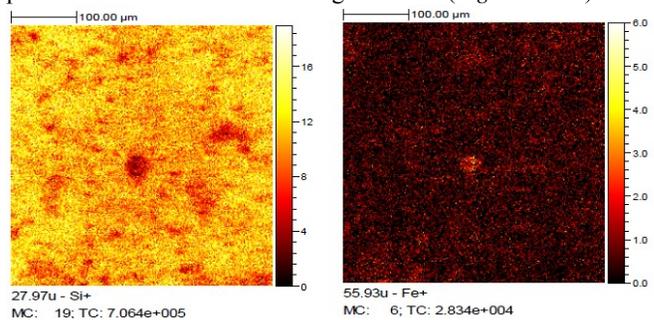
After sputter cleaning the majority of the remaining organics, PDMS, Cl and F have been removed. In the positive SIMS maps the presence of metals (iron) at the centre of the damage structure becomes evident. Also notable is the corresponding depletion of silicon which correspond to the presence of a metallic particle (i.e Fe) in or on the coating as a potential root-cause for the damage creation (*Figure IV-13*).

Figure IV-13 Aladin Laser FM-A output window: SIMS maps of Si+ and Fe+ after sputter cleaning.

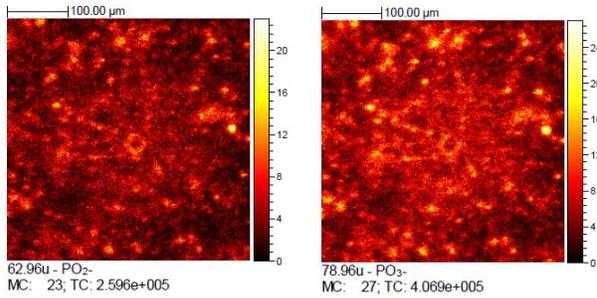
Analysis of negative ions maps shows (*Figure IV-14*) significant residual of the phosphate deposits still present after Ar cluster sputter cleaning.

Figure IV-14 Aladin Laser FM-A output window: SIMS maps of PO_2^- and PO_3^- after sputter cleaning.

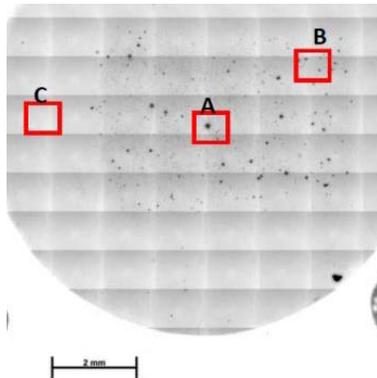
The absorbing features themselves show a consistent chemical make-up with the damage structures. The best sample to visualize the dot like features without any damages (which have a potential to relocate contaminants) is a flight hard-ware grade Half Wave Plate coming from a test set-up (Figure IV-15).

Figure IV-15 HWP from Airbus Toulouse laser test set-up.

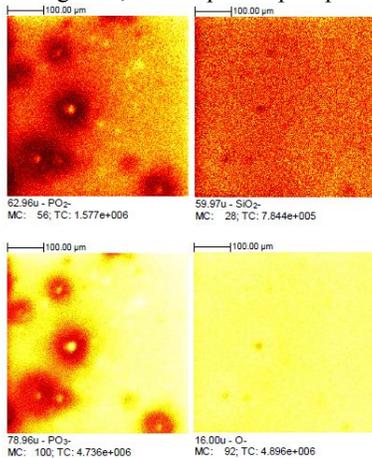
Figure IV-16 Area B negative maps: PO_2^- , SiO_2^- , PO_3^- , O^- .

In area B where only dot like features are present, the negative ion maps show the usual good correlation between phosphates and surface structures. The centers of the dot like features show higher phosphate content than the borders. This may be due to view factors, and may also hold for the damage features.

Significantly no accretion (in fact a faint depletion can be surmised) of SiO_2 , Si or O is visible in correspondence with the dot like features. This tentatively rejects the hypothesis of an origin linked with silicones (PDMS are present on the surface but their localization is also not germane).

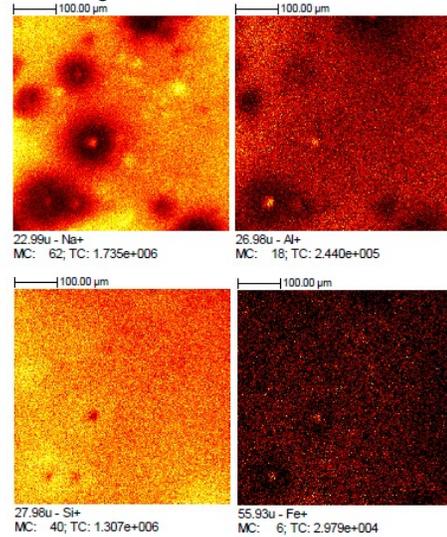
As far as the positive ion maps are concerned it is important to recognize the presence of metals associated with some (but not all) of the features.

Figure IV-17 Area B positive maps: Na^+ , Al^+ , Si^+ , Fe^+ .

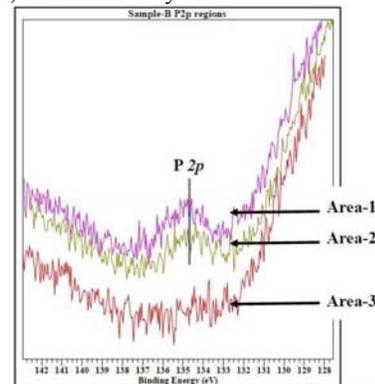
The presence of a phosphorous content in irradiated area, but not outside, is confirmed by XPS.

Figure IV-18 Phosphorous $2p_{1/2+3/2}$ peak, coming from phosphates. Concentration in Area-1 beam footprint, centre, Area-2 beam footprint periphery, Area-3 control area outside of beam.
